Earthquake and Mine Subsidence:

DIFFERENT PERILS —
SEPARATE INSURANCE
COVERAGE

ILLINOIS MINE
SUBSIDENCE
INSURANCE FUND

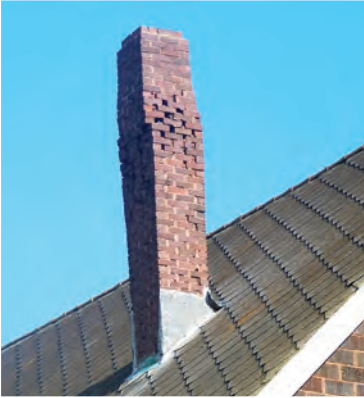
Chimney damage from earthquake shaking caused this chimney to sway back and forth. This type of damage is found on old chimneys with soft, deteriorated mortar. Chimneys with strong intact mortar sometimes break off at the roof line.

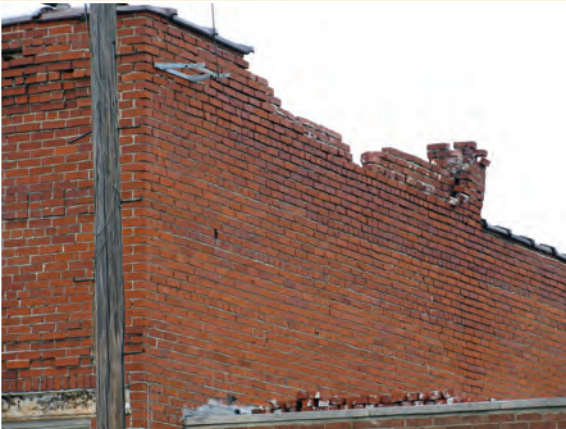
Parapet wall and part of chimney is shaken down with bricks landing on adjacent building's roof.

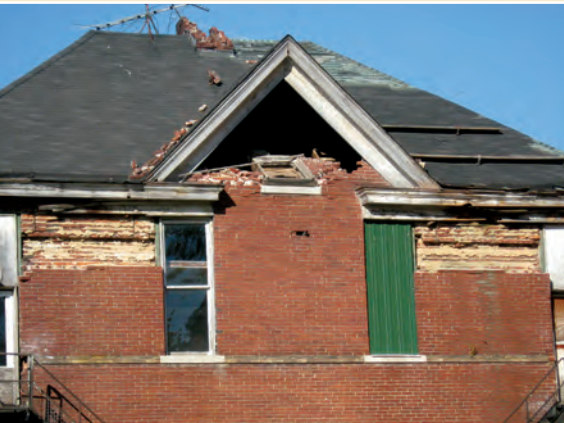
This shows the effects of earthquake shaking on an old brick bearing wall building — the chimney is down, and the top of the wall has caved into the building.

Earthquake damage results from shaking caused by surface waves. Damage can take many forms, depending on the severity of the earthquake. Light earthquake damage is usually first visible in the structure built above the basement or foundation, or *superstructure* — most likely cracks in plaster or wallboard. Moderate damage will be evidenced at the higher points of a structure, specifically to unreinforced building components such as chimneys, parapets, cornices and ornamentation. It is quite possible for an earthquake to cause such damage while leaving the foundation intact. Severe damage could result in partial or total collapse of structures.

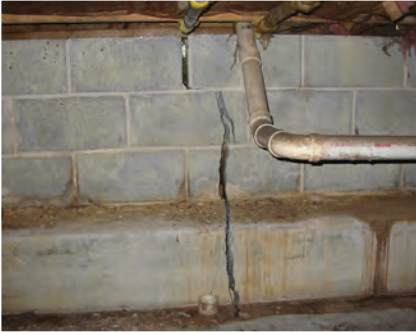
Figure 1

These structures are located in or near the edge of the event, or slope zone. Horizontal pulling of the foundation can cause dramatic vertical breaks in the foundation walls and footing (Figure 1), and mortar joint step cracks in the brick veneer (Figure 2). Both of the structures shown are being pulled towards the center of the mine subsidence event.

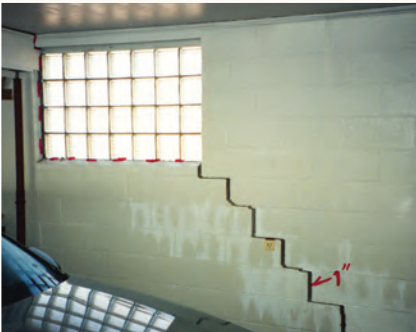
Horizontal pulling of the foundation causes mortar joint step cracks, vertical breaks in the foundation walls, and separations in the footings.

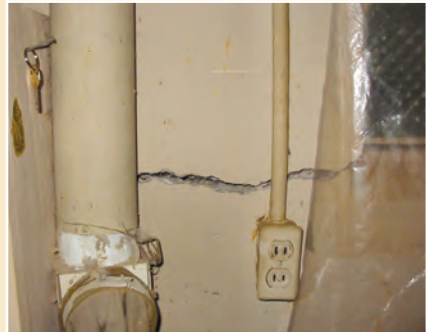
This poured concrete basement wall is being compressed, (near the center of the mine subsidence sag) or being pushed inward, causing a sizable crack extending along the foundation wall.
