# Mine Subsidence in Illinois: Facts for Homeowners

Circular 569 2013 2nd edition

**ILLINOIS STATE  
GEOLOGICAL SURVEY**  
PRAIRIE RESEARCH INSTITUTE

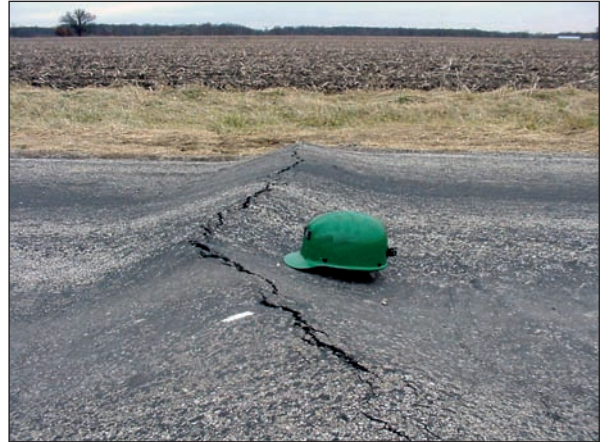
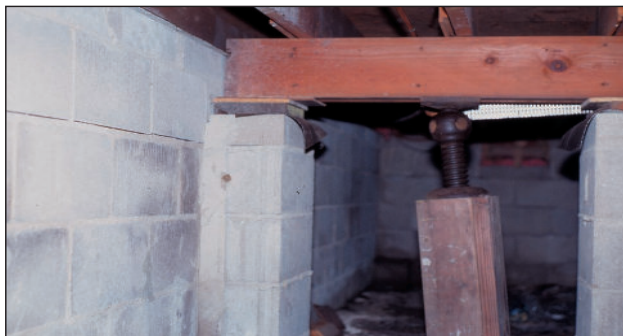
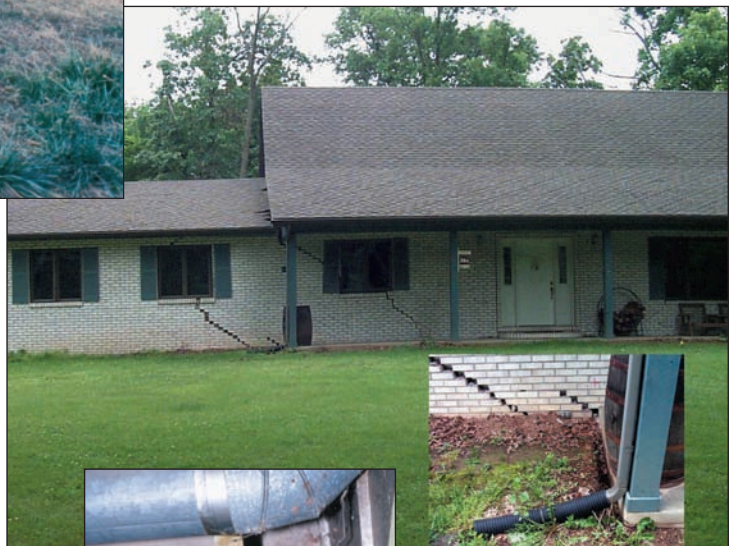
**Front Cover:** (a) Tension cracks formed in the ground surface extending through a home; the foundation has settled at the house corner closer to the center of sag. (b) Compression ridges formed in a road as the result of ground movement (compression) associated with coal mine subsidence. (c) The brick-sided house in the tension zone shows downward bending (compare roof lines). The left side of the home is closest to the sag center and has dropped down. Inset: ground has pulled away from the porch toward the sag center (left). (d) Settlement of the main beam caused by construction problems. (e) This basement damage was unrelated to mine subsidence. It was caused from decades of seasonal wetting and drying of soils, which built up pressure against the basement foundation walls. With each cycle, dryness allows fine grains of soil to fall into the gap between the soil and the foundation wall. When moisture returns, the soil expands, increasing pressure until the wall fails and is pushed inward.

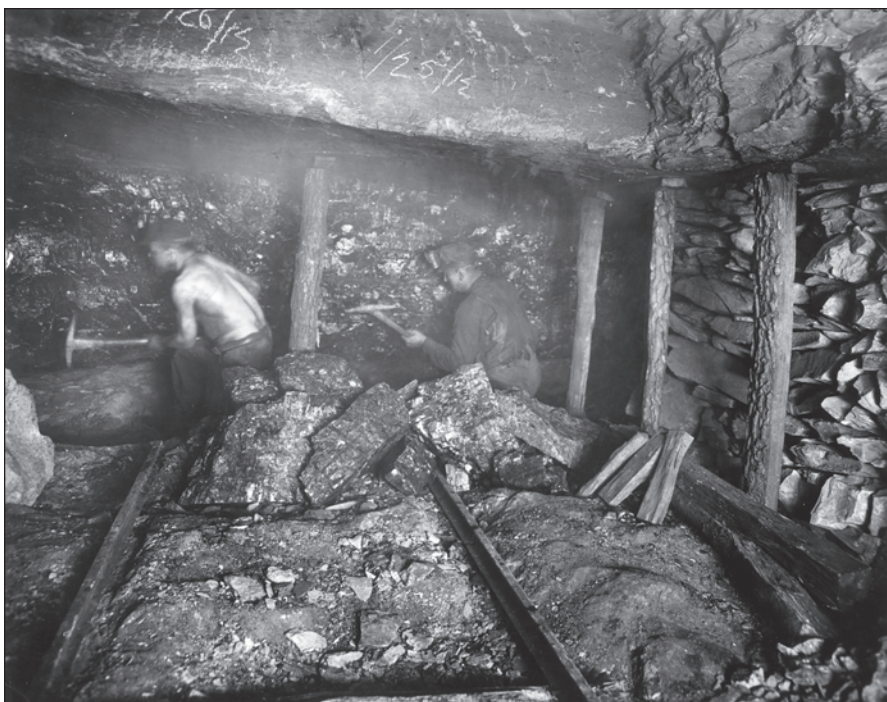
**Figure 5** Photograph of mining at the face in an early longwall mine. Note the stacked rock support on the right side. More than 145 of these mines operated from 1856 to 1954 in 18 counties. Most were located in the northern counties from Bureau, LaSalle, Grundy, and Will (fig. 2).

In the late 1800s and early 1900s, longwall mines (figs. 5 and 6a) were excavated by hand, and workers maintained the haulageways (entryways) by placing stacked rock, wooden props, and rock-filled wooden structures to replace the support lost by the removal of coal. The mine roof and the rest of the overburden’s weight settled onto the stacks of rock and compressed them. When this occurred, a few feet of subsidence resulted at the ground surface over the entire mined area.

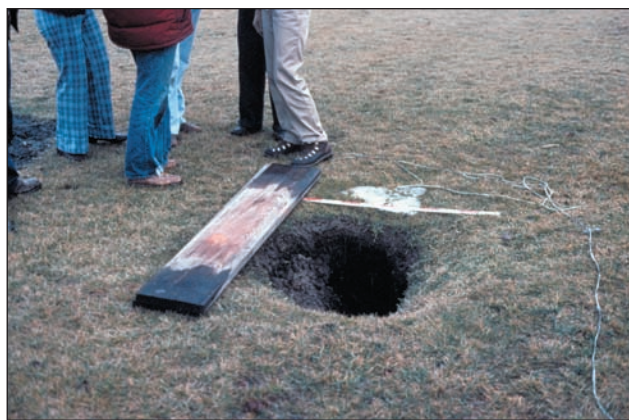
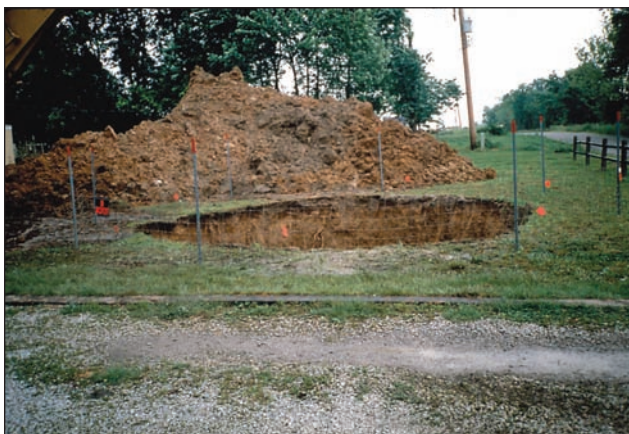
**Figure 8** Diagram (Wildanger et al. 1980) and photographs of typical pit subsidence events.

Pit subsidence mostly occurs over shallow mines that are less than 100 feet deep and where the bedrock over the mine is less than 50 feet thick and composed of weak rock materials such as shale. The pit is produced when the mine roof collapses and the roof fall void works its way up through overlying thin, weak bedrock and surficial layers to the ground surface. Pit subsidence forms very quickly. If the bedrock is only a few feet thick and the surficial deposits are loose, these materi-

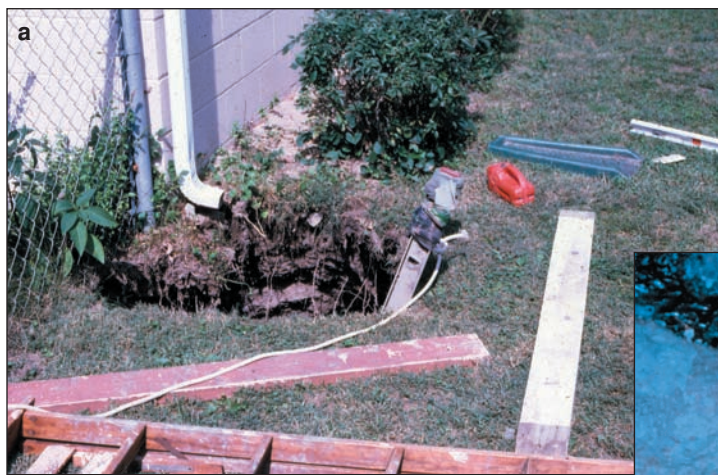
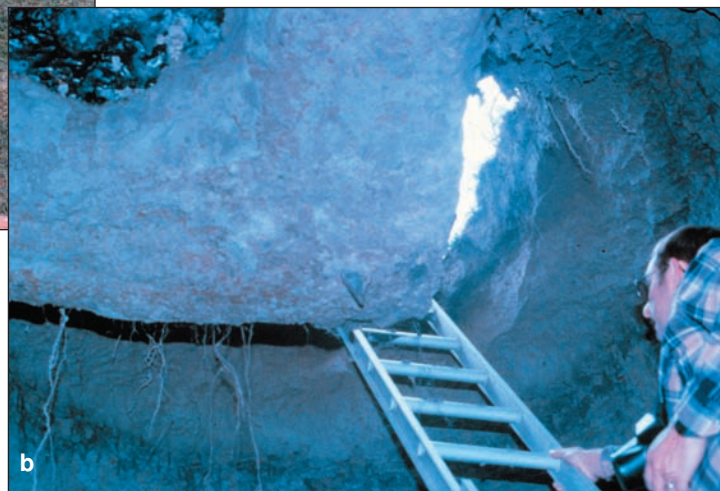
**Figure 9** Pit subsidence under the corner of a house from (a) above and (b) below ground.

develops under the corner of a building, the support posts of a foundation, or another critical spot. Otherwise, the probability of a structure being damaged by pit subsidence is low because most pits are relatively small—only a few feet across. If pit subsidence develops under foundation walls, the house may not be affected immediately because the foundation may temporarily bridge the pit (figs. 8 and 9). Left unfilled, the structure (bridge) may become damaged from lack of support.

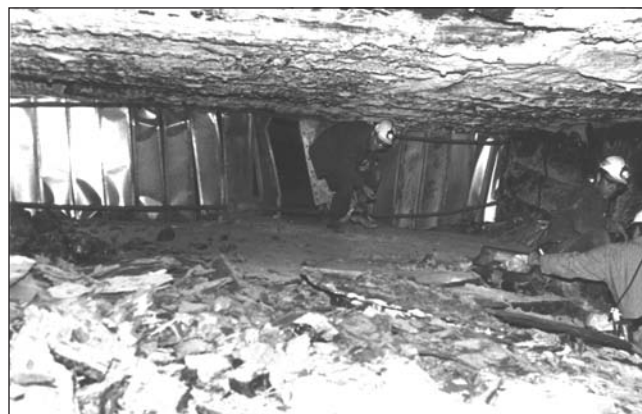
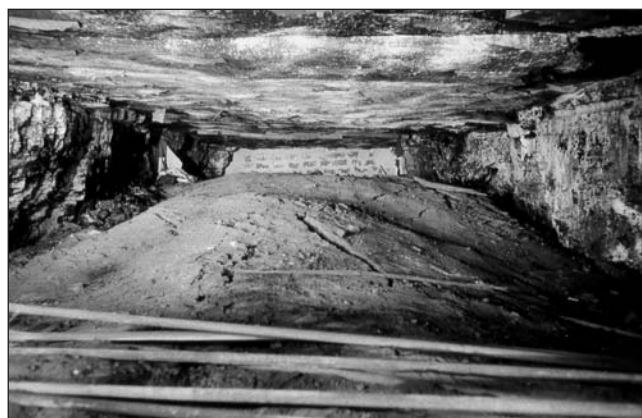
**Figure 12** Diagram and photographs of coal pillars being pushed into a soft floor. The claystone material is being squeezed out from under the pillar up into the entryway.

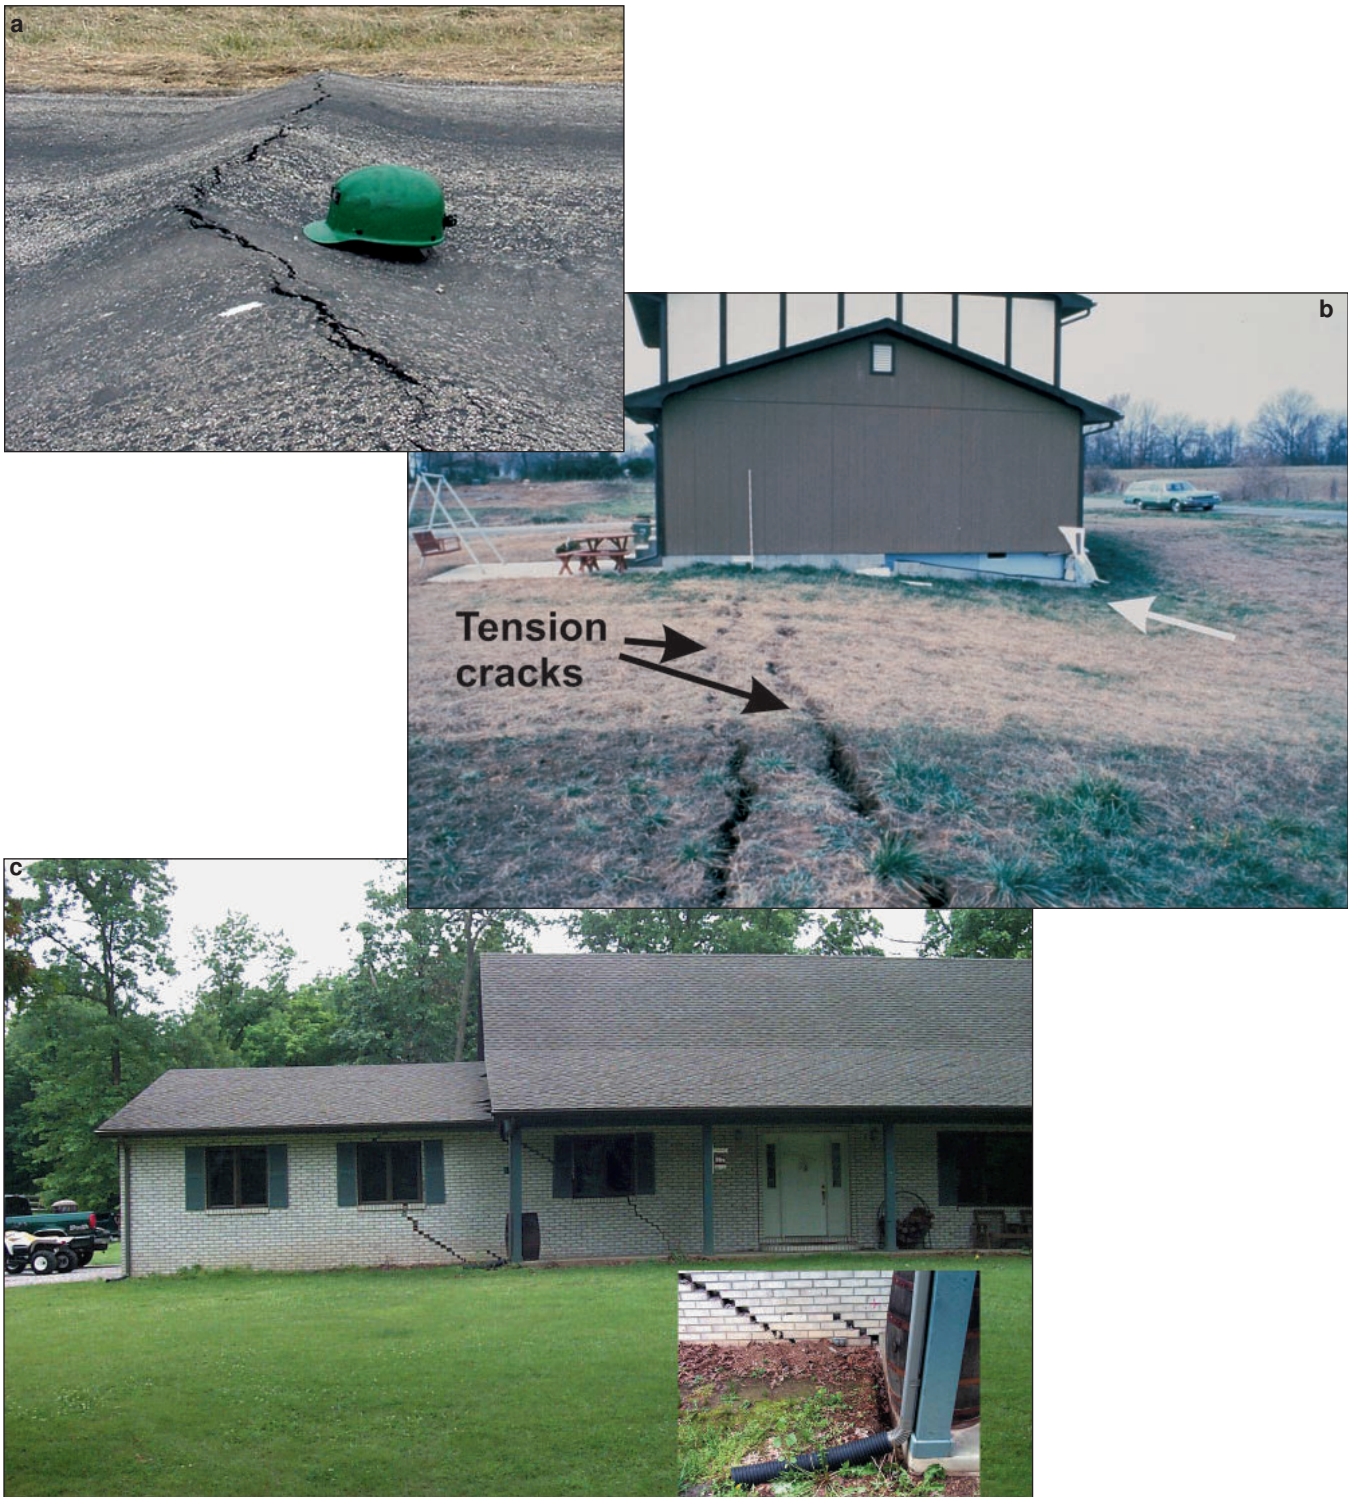
**Figure 14** Photographs illustrating the sag subsidence event and features shown in figure 13. (a) Compression ridges formed in the road (feature R) as the result of ground movement (compression) associated with coal mine subsidence. (b) Tension cracks form in the ground surface extending through a home (feature H1); the foundation has settled at the house corner close to the center of the sag. (c) The brick-sided house (feature H2) in the tension zone shows downward bending (compare roof lines). The left side of the home is closest to the sag center and has dropped down. Inset: Ground has pulled away from the porch toward the sag center (left).

The ground moves in two directions during sag subsidence (figs. 13 and 14). The ground drops vertically and moves horizontally toward the center of the sag. At the surface, the sag may be much broader than the collapsed part of the mine. For example, a failure in a mine 160 feet deep could cause minor surface subsidence more than 70 feet beyond the edge of the collapsed area underground (edge of panel). The deeper the mine, the larger the area affected out over the unmined area. Collapsed areas in abandoned underground mines may occur in only part of a panel or mined-out area (fig. 15).

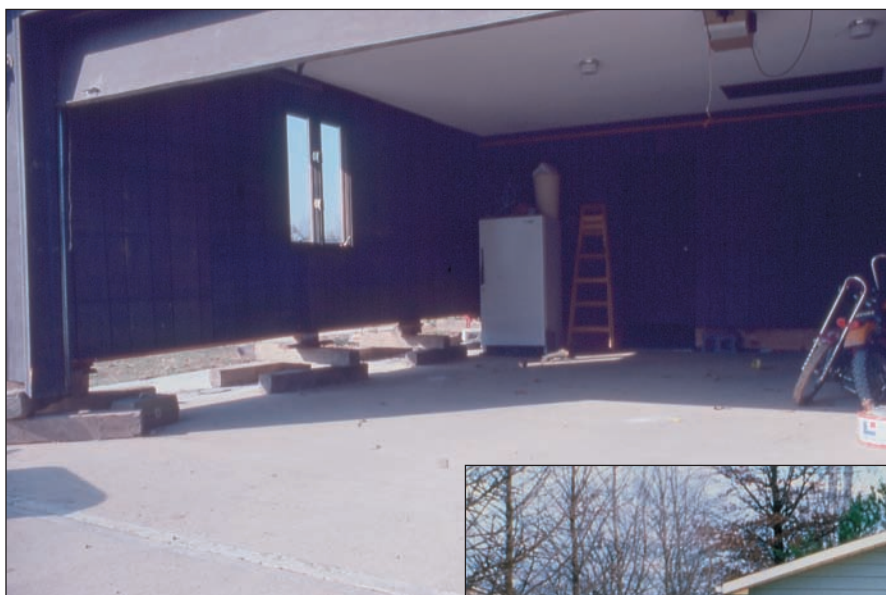
**Figure 16** Load-bearing walls of a garage on a slab. The entire superstructure (frame) has been raised to a level position, exposing the interior of the garage. This re-leveling eliminates damaging stresses from differential movements of the foundation and maintains the superstructure level throughout the life of the event.

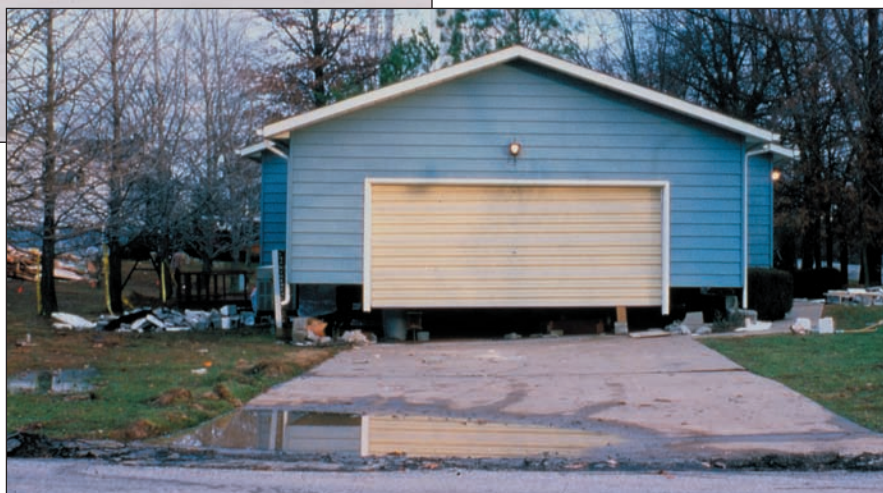
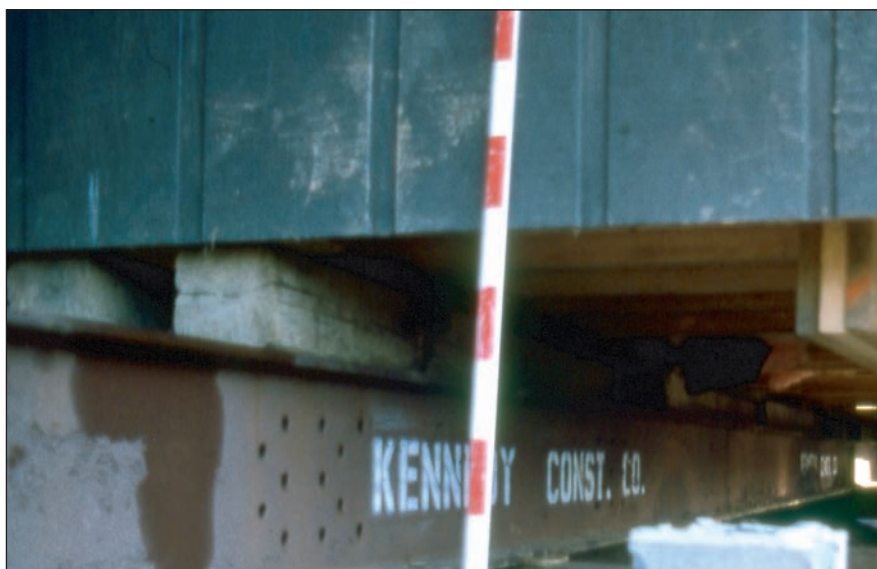
**Figure 17** Concrete blocks of a crawl space have been removed to make room to jack the house to a level position. I-beams support the re-leveled house.

**Houses with crawl spaces** Some houses are supported by perimeter footings with foundation walls (and interior piers when necessary) so that a crawl space is created between the floor and the ground surface. Bolts attaching the foundation to the wood frame are generally visible and accessible within the crawl space. Once the house is detached from its foundation and support beams are placed under it, the house can be raised to a level position. If foundation walls are constructed of concrete blocks, sections of the wall may be easily removed so that supporting beams can be inserted under the superstructure (frame) of the building (fig. 17). The family can usually continue to occupy the house because the floor is attached to the frame and raised along with it. Typically, temporary steps are constructed to allow access.

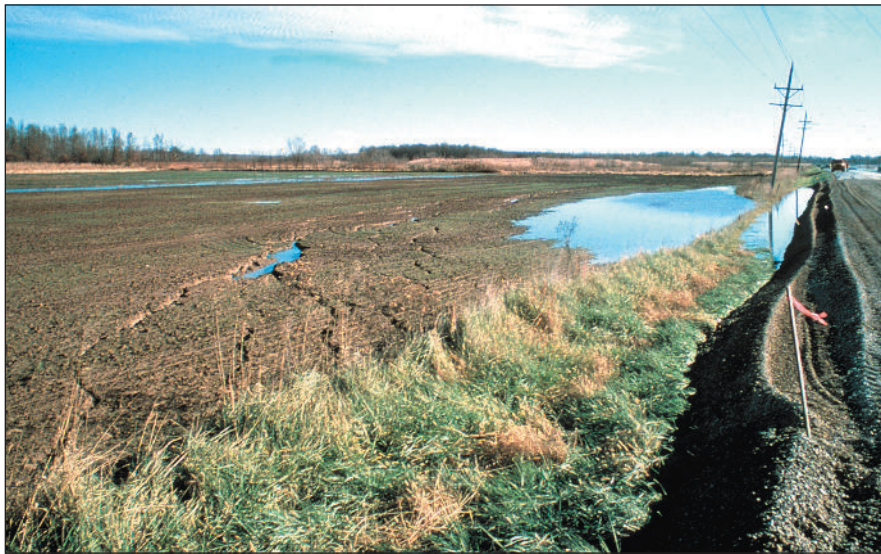
**Figure 18** Ponding created by sag subsidence. Note the tension cracks around the edge of the depression.

Water can also pond in a sag subsidence event (fig. 18). If any part of a house is in a sag, an attempt should be made to keep water from accumulating around and under it. The ground surrounding the foundation must be kept well drained

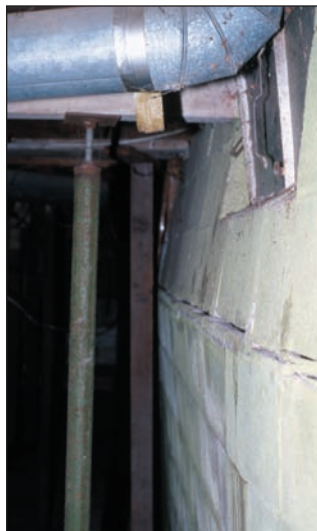
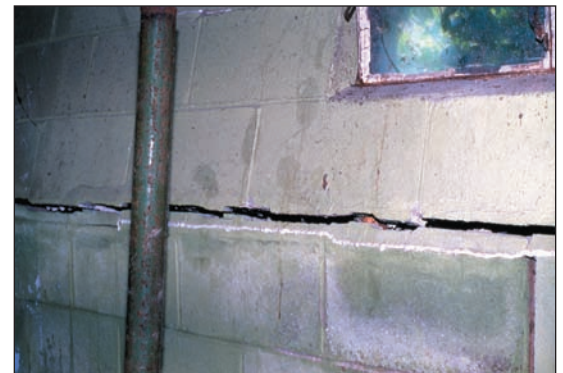
**Figure 19** Basement damage unrelated to mine subsidence. Damage was caused from decades of seasonal wetting and drying of soils, which built up pressure against the basement foundation walls. With each cycle, dryness allows fine grains of soil to fall into the gap between the soil and the foundation wall. When moisture returns, the soil expands, increasing pressure until the wall fails and is pushed inward. Block basement foundation walls can also be pushed inward by loading the ground surface near the foundation wall with a car driving or parked on a soil or gravel driveway or use of heavy construction equipment.

**Shrinking and swelling** Moisture-sensitive soils expand when wet and shrink when dry. Many decades of cyclic wetting and drying build up pressure against block basement foundation walls as soil and other debris fall into the space between the foundation wall and the dry, shrunken soil. Pressures build until basement walls are pushed inward, forming horizontal cracks that continue across the length of the wall until they propagate downward in a staircase pattern near the corners. Often these cracks form on all walls but tend to be more severe along the longer, load-bearing walls of rectangular-shaped homes. Typically, these horizontal cracks form a foot or more below the ground surface. If the walls move inward an excessive amount, the floor of the house may drop and tilt (fig. 19).

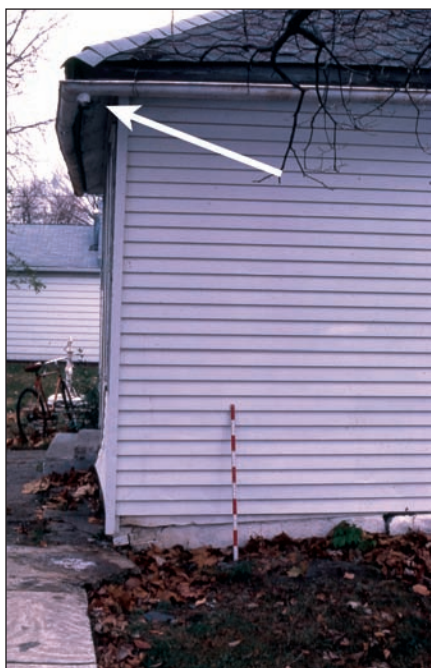
**Figure 20** Foundation sinking at the corner of a building due to reduced support caused by excessive, repeated moisture changes. Note gutter drainage (arrow) and lack of downspout to channel drainage away from the foundation.

Reduced load-bearing support of the soil can cause foundations to tilt or sink at the corners (fig. 20). To avoid problems, homeowners should take measures to keep excessive amounts of water away from foundation walls. Downspouts should discharge water several feet from the house. The soil should be built up around the house and graded to slope away from the foundations so that water will then drain away from the house. The cracks produced in foundations by this rotating downward movement of the corner are wide at the top of the foundation and decrease to a nearly hairline crack near the base (footing) of the foundation. This pattern is in contrast to that

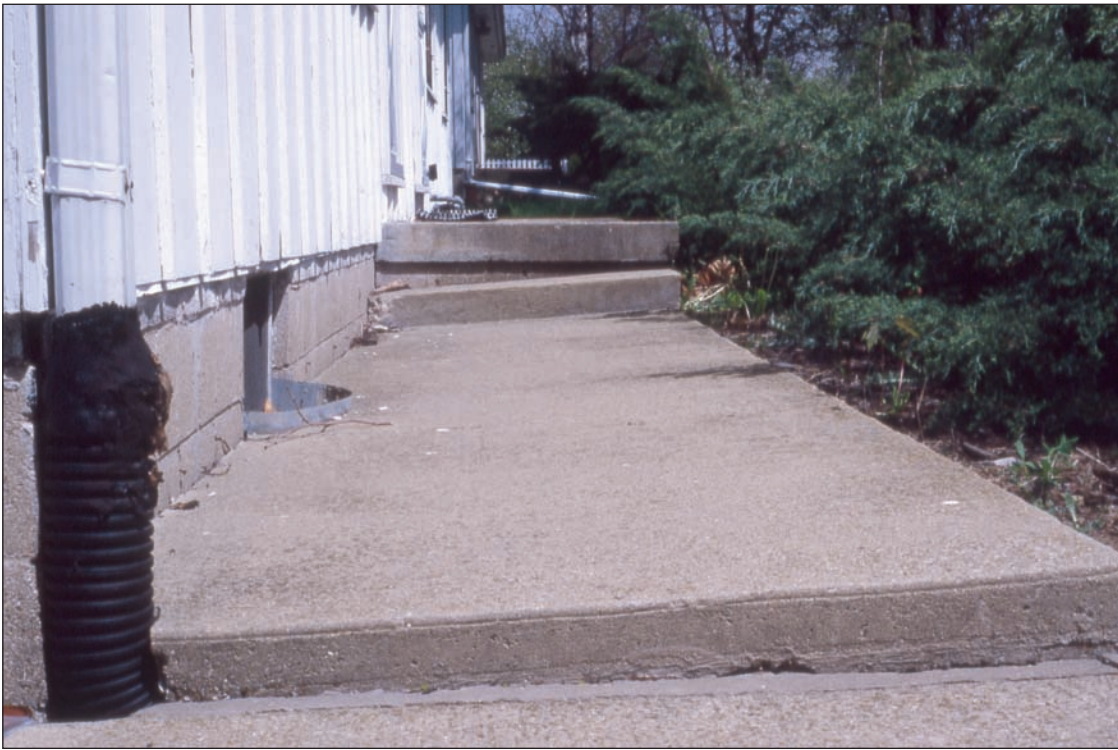
**Figure 24** A moat-type depression along the foundation wall and lowered sidewalk and patio slabs caused by the kind of peripheral drainage system shown in figure 23.

**Piping** Piping, or subsurface erosion from water washing away fine-grained soil, can occur along broken or separated sewer lines, water lines, old farm tile, and buried downspout extensions (fig. 22). Older drainage systems around the outside base of the foundation—the peripheral drainage system—slowly remove soil particles and lower the ground surface around the house (fig. 23). This removal causes sidewalks, stairs, and patio slabs located along the foundation to drop and tilt toward the house (fig. 24).

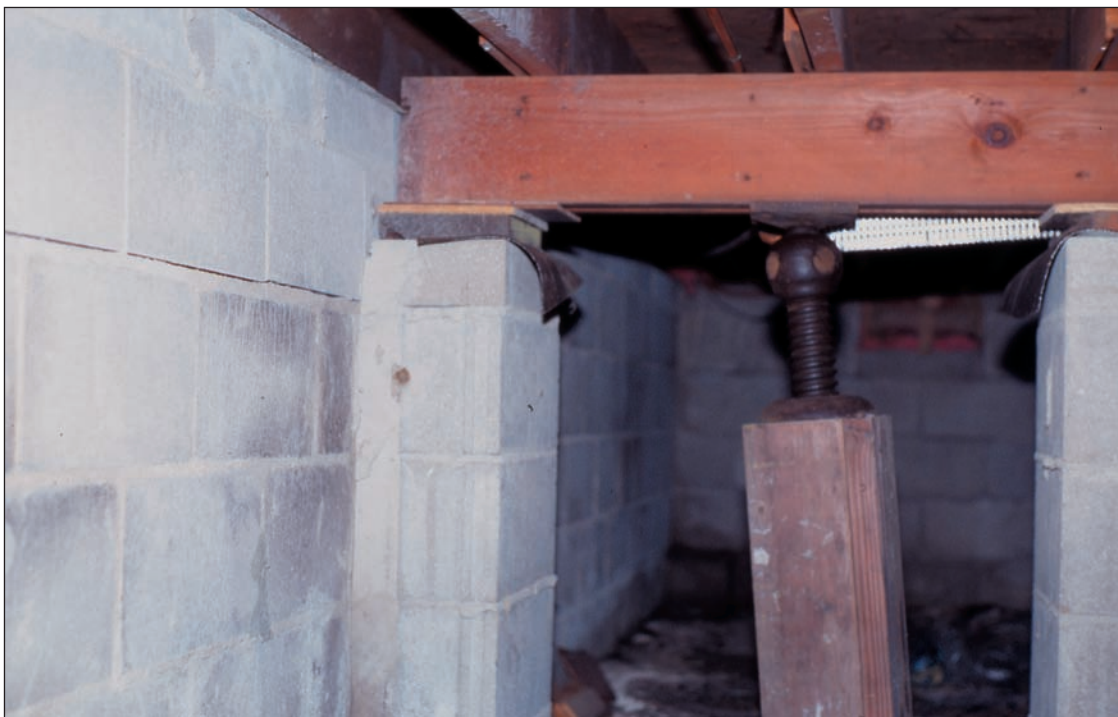
**Figure 25** This main beam is not attached directly to the foundation wall. Because the beam is settling a different amount than the foundation and because some of the thick layers of shims are compressing, cracks have developed in the house above the beam.

Vertical intermediate supports for the main beam of a house may sink if they do not rest on properly sized concrete footings. Many times concrete blocks are used in crawl spaces to support the main beam running down the center of the house. Sometimes these blocks are resting directly on the soil, and, because they do not provide enough bearing area, they will sink into the soil. If there is inadequate contact area between a beam and a vertical support, enough weight can be concentrated onto the beam to crush it, thus lowering the floor. Also, if a thick stack of shims has been used between the beam and the vertical support, the shims may compress, lowering the beam (fig. 25). The ends of the main beam should

rest on the foundation walls to reduce the likelihood of the beam moving a different amount than the foundation and causing cracks to develop in the walls above this location. Insufficient spacing and floor joist size can result in sagging floors, a condition sometimes mistaken for subsidence.

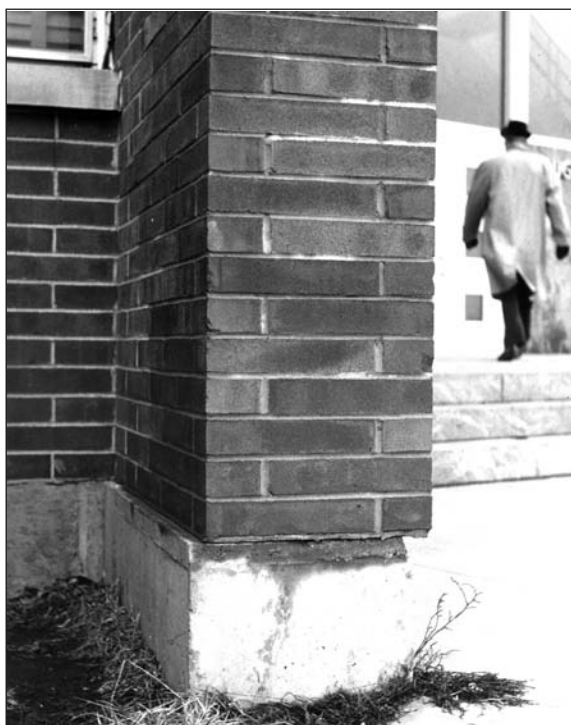
**Figure 28** The largest movements are at the edges of the long, continuous wall. At this point, the short brick wall is being pushed off the foundation by the long, continuous brick wall to the left.

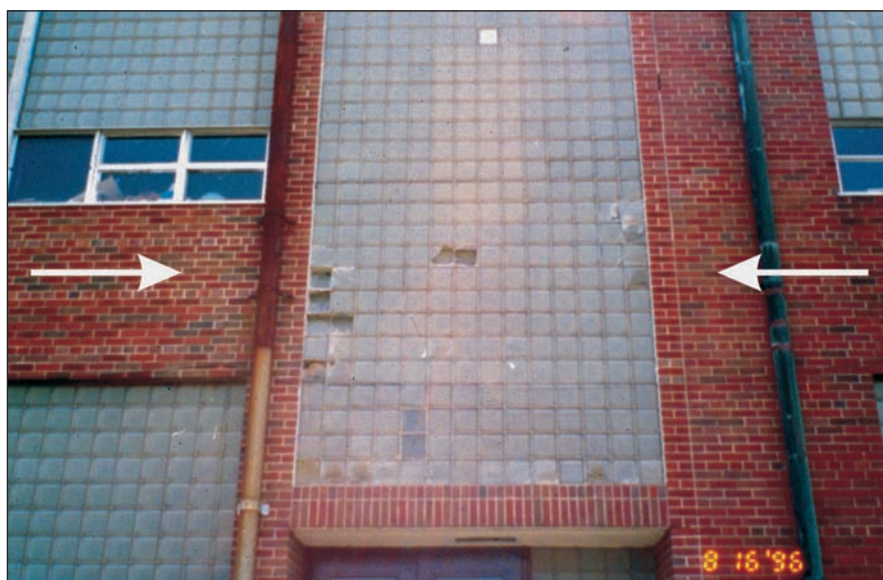
**Figure 29** The long, continuous brickwork intersects the vertical glass block wall. Pressures have broken the glass blocks in line with the long, continuous expanse of brickwork.

blocks, may be crushed (fig. 29), and the sliding wall may become separated from the interior floor slab. To minimize this type of problem, functioning expansion joints should be incorporated into the construction. Expansion joints should be clear of any hard materials that may have fallen in during construction, and pliable caulk should be used to seal the gap.
