ILLINOIS MINE  
SUBSIDENCE  
INSURANCE FUND

# Earthquake and Mine Subsidence: Different Perils — Separate Insurance Coverage

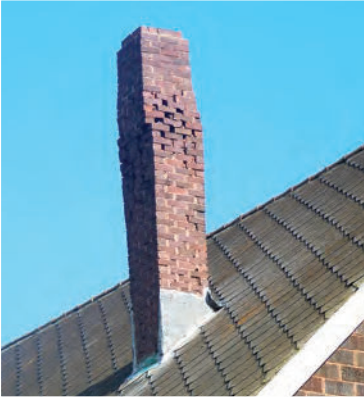
Chimney damage from earthquake shaking caused this chimney to sway back and forth. This type of damage is found on old chimneys with soft, deteriorated mortar. Chimneys with strong intact mortar sometimes break off at the roof line.

Earthquake damage results from shaking caused by surface waves. Damage can take many forms, depending on the severity of the earthquake. Light earthquake damage is usually first visible in the structure built above the basement or foundation, or *superstructure* — most likely cracks in plaster or wallboard. Moderate damage will be evidenced at the higher points of a structure, specifically to unreinforced building components such as chimneys, parapets, cornices and ornamentation. It is quite possible for an earthquake to cause such damage while leaving the foundation intact. Severe damage could result in partial or total collapse of structures.

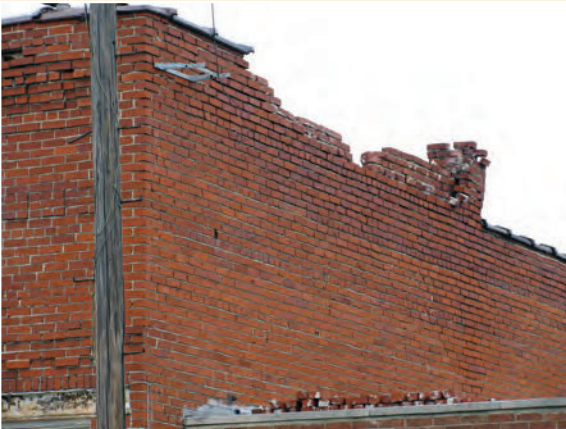
Parapet wall and part of chimney is shaken down with bricks landing on adjacent building's roof.

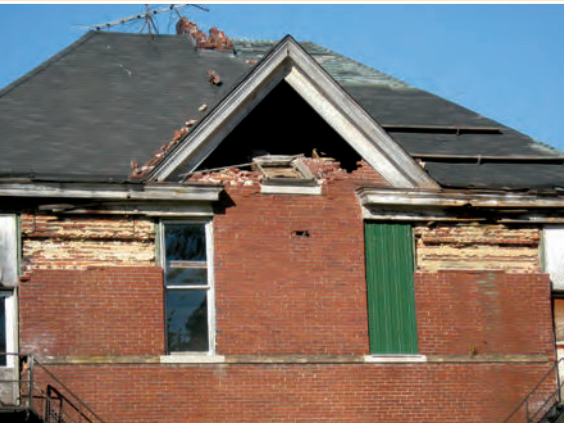
This shows the effects of earthquake shaking on an old brick bearing wall building — the chimney is down, and the top of the wall has caved into the building.

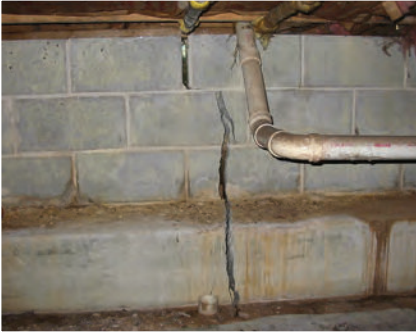
Figure 1

These structures are located in or near the edge of the event, or slope zone. Horizontal pulling of the foundation can cause dramatic vertical breaks in the foundation walls and footing (Figure 1), and mortar joint step cracks in the brick veneer (Figure 2). Both of the structures shown are being pulled towards the center of the mine subsidence event.

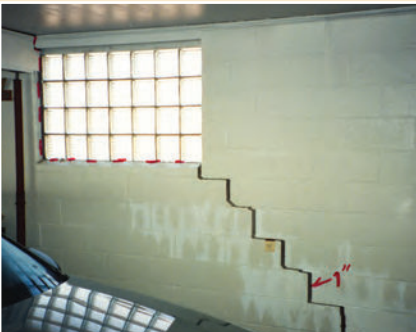
Horizontal pulling of the foundation causes mortar joint step cracks, vertical breaks in the foundation walls, and separations in the footings.

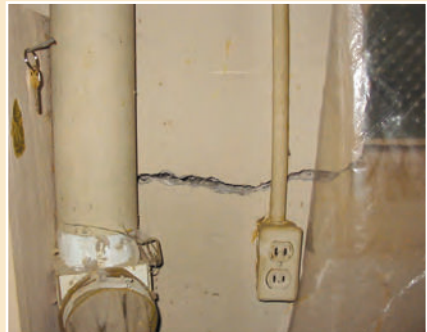
This poured concrete basement wall is being compressed, (near the center of the mine subsidence sag) or being pushed inward, causing a sizable crack extending along the foundation wall.
